NORTH AMERICAN TOWER FAILURE

CAUSES AND CURES

DAVID K. DAVIES

CONSOLIDATED ENGINEERING, INC

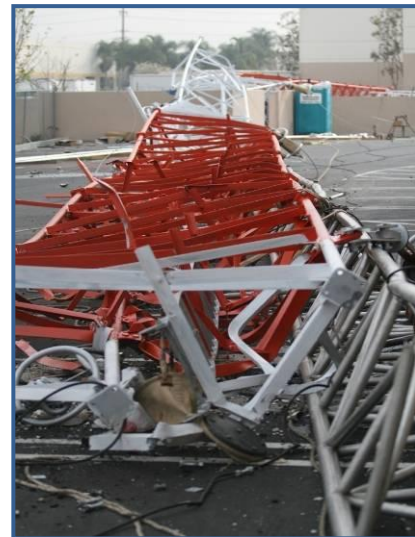
March 18, 2008 – “On Saturday, KFI-AM personnel welcomed the long-awaited construction of their 684-foot guyed tower in La Merida, CA. However, at 2:04 P.M. today, they watched in disbelief as the new tower crashed to the ground as a tower crew prepared to pull tension on the third level of seven guy wires. A tower rigger employed by the erection contractor, Seacomm Erectors, Inc. of Sultan, WA, received minor injuries. The tower was engineered and manufactured by Magnum Towers, Inc. of Sacramento, CA.”

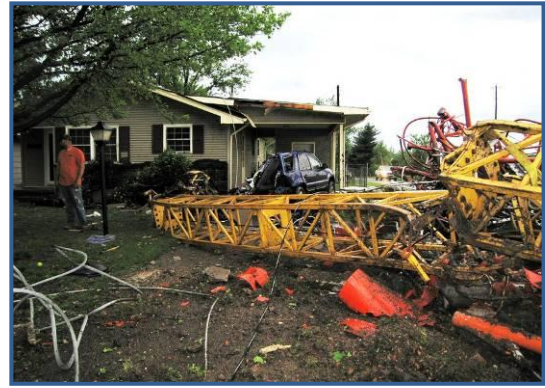
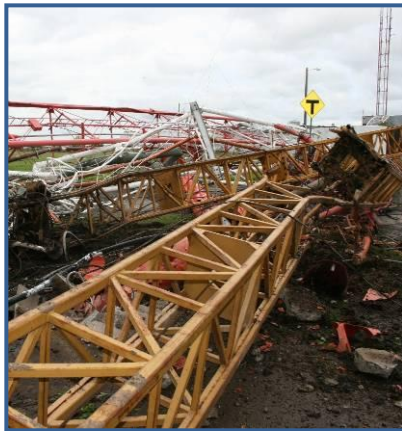
Joplin, MO -- “About half of the KSNF-TV tower came down this morning during an antenna change. A large section of the broadcast tower fell, crushing a vehicle and causing damage to several homes in the area” *Joplin Globe, May 8, 2009.*

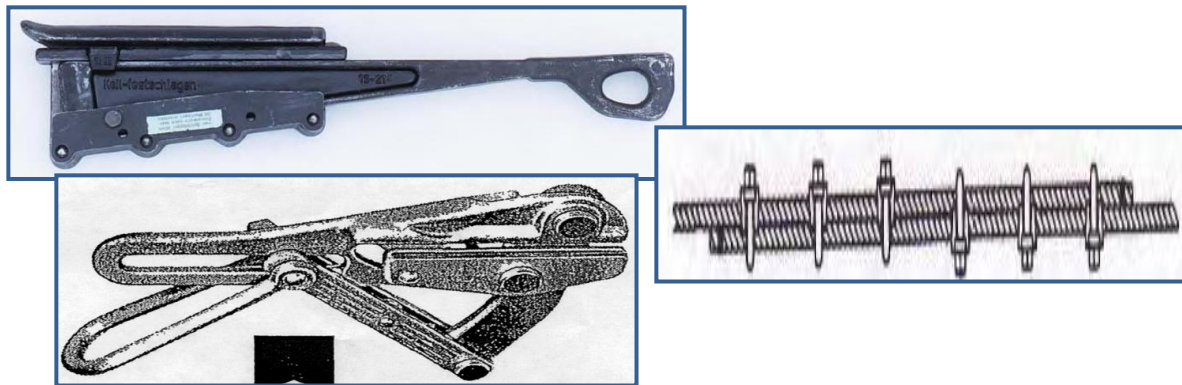
The following tools and attachments *known* to slip guy wire:

(In-line cable splices and Friction type grips without turn-backs)

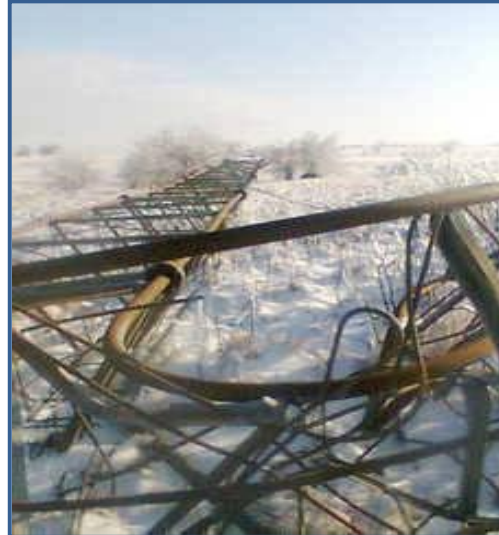
WATERLOO, February 24, 2007 - The upper half of the **KHKE** tower collapsed during an ice storm. "*There was over an inch of ice on the tower, and coupled with 30- to 40-mph winds, it just toppled.*" said KHKE and KUNI General Manager Wayne Jarvis.

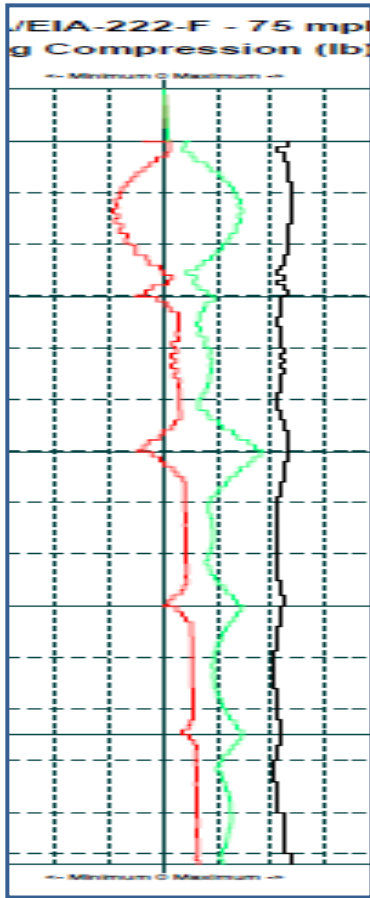
75 mph with No Ice:

When the tower was analyzed using the original design code, **EIA 222-C**, no structural deficiencies were noted, but ice accumulation was not considered, either.

In the following diagrams, the green line indicates the tower leg compression stress. The heavy black line indicates the tower leg capacity. The diagram on the left portrays the tower leg stress to capacity in the “no ice” condition. The diagram on the right portrays the tower leg stress to capacity considering the optional and “purchaser specified” ice condition.

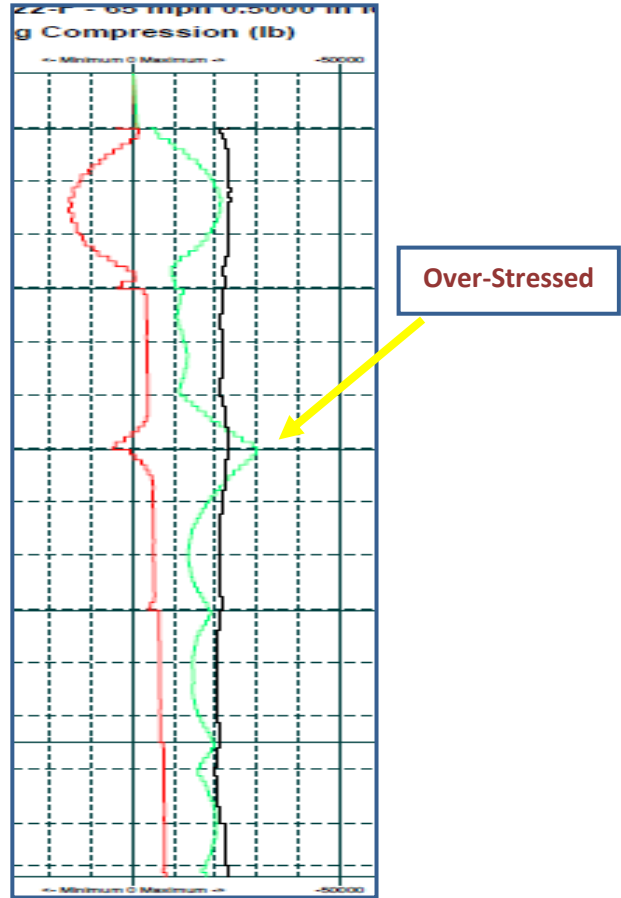
65 mph with 1/2 inch of Ice:

Note *above right*, the over-stressed condition, using the TIA/EIA-222-F reduced wind speed and 1/2 inch of ice, is clearly visible in the mid-section of the tower.

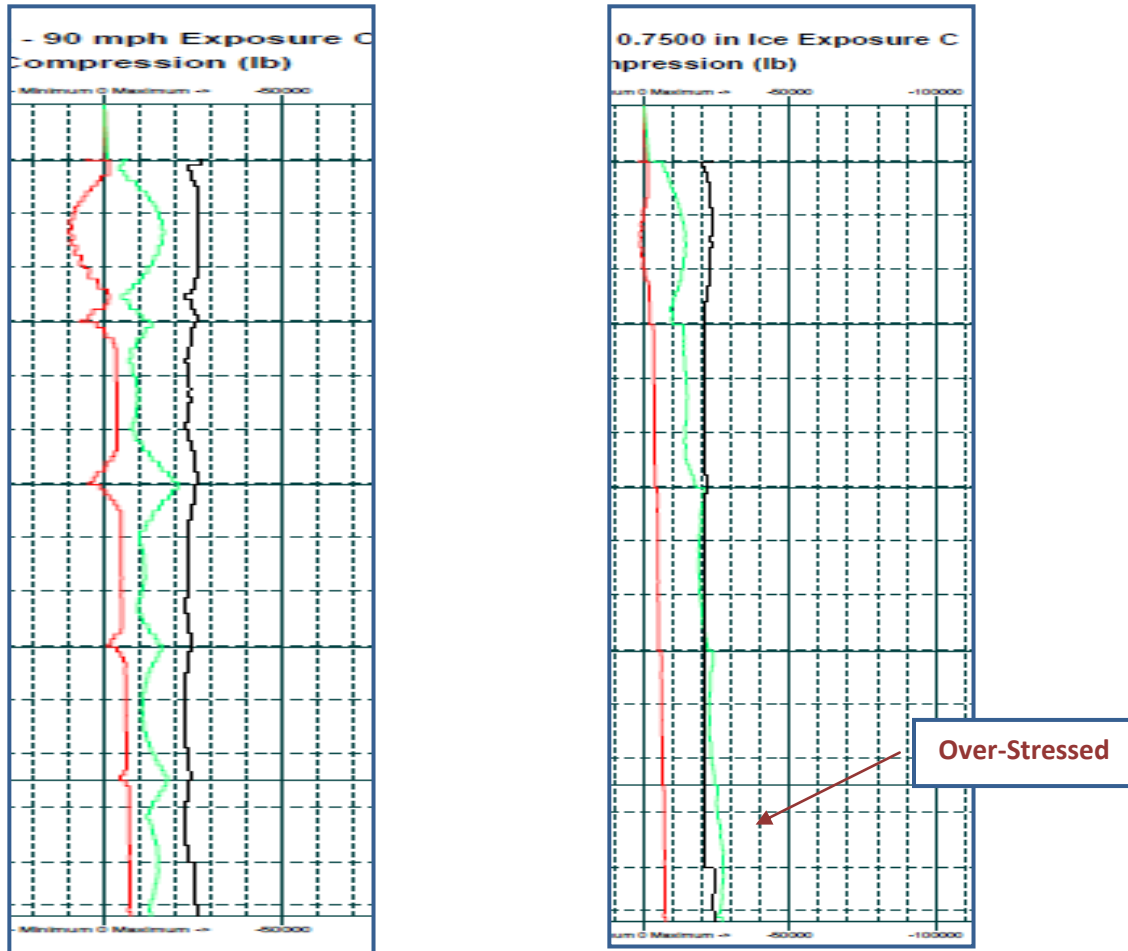
Rev G 90 mph (3 sec) = Rev F @ 70 mph Rev G 40 mph (3 sec) with ¾ inch ice escalating

Using the **Rev G**, the tower legs are no longer over-stressed in the mid-section, as was the case using the older **F Standard**. Now, stress is indicated in the lower section of the tower legs.

The high wind speed of **222-F** with ½ inch of ice may also cause one or more levels of upper tower guys to be replaced, in contrast to using **222-G** tower wind speed with more ice, which would find the guys satisfactory.

If the original tower was reinforced to meet the less accurate ‘**F**’ code load, this reinforcement would have created additional stress to those portions of the tower previously deemed insufficient using the ‘**G**’ code analysis. In other words, reinforcing this tower to meet the deficiencies indicated in the “**F**” Standard analysis would actually increase the likelihood of failure. Why?

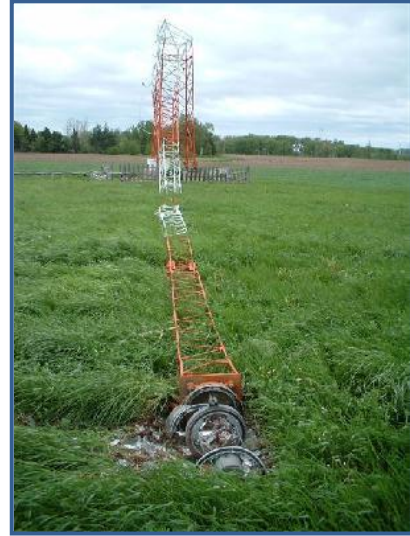
“On Saturday, May 10, 2003, a strong storm moved through the Midwest. A tornado touched down in Peoria, IL. Three out of the four towers were toppled.” See photo, right

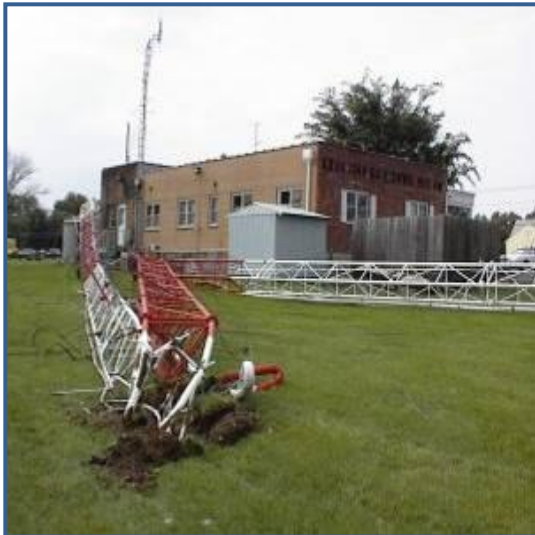
“About 10:30 Wednesday night (8/23/00), a thunderstorm with straight line winds in excess of 60 mph moved through Mexico, MO.” Gary Leonard: KXEO and KWWR's tower failure August 2000. See photo, left

Keep in mind, minimum design wind criteria for this area was 70 mph, fastest mile wind speed. According to the news report, the tower failed during a 60 mph wind gust (3-second average wind speed) when the tower was allegedly designed to meet a 70 mph fastest mile wind speed which is equivalent to an 85 mph gust or 3- second average wind speed!

In other words, the tower should have been able to withstand a gust or 3-second-average wind speed of 85 mph, yet fell during a 60 mph gust. Was this tower failure really a result of excessive wind speed? Probably not, but insurance companies won't pay when poor designs or improper maintenance are to blame.

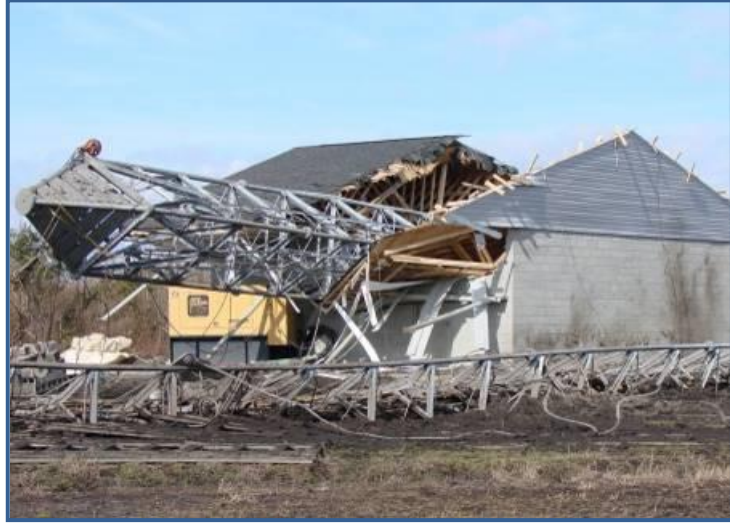
December 11, 2007 © By Phillip Walzer “*The parent company of WSKY-TV has sued the builder of a tower that toppled in 40 mph winds in Camden County, N.C., in March, saying its work was shoddy from start to finish.*” Walzer commented further saying “*The suit reads like a lament against a sloppy contractor.*”

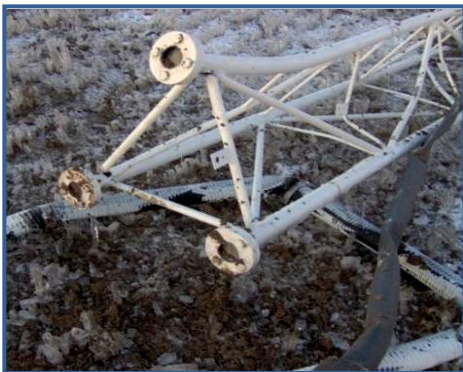
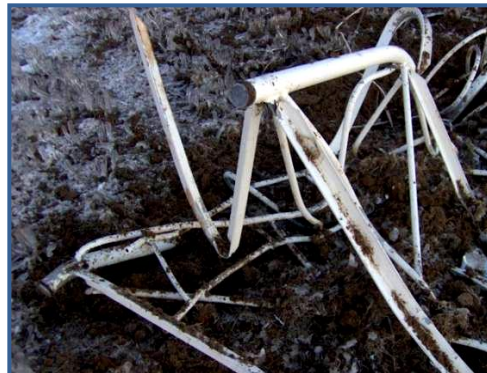
Fabrication refers to the methods used to piece a tower together in the shop. The margin for error with respect to fabrication is very small. These startling photos, borrowed from my Power Point presentation, were taken after a tower collapsed. They illustrate just *one* of the many possible types of fabrication errors. The reason for collapse was *insufficient weld penetration* causing a tower leg to break free from the flange. *See photos, below.*

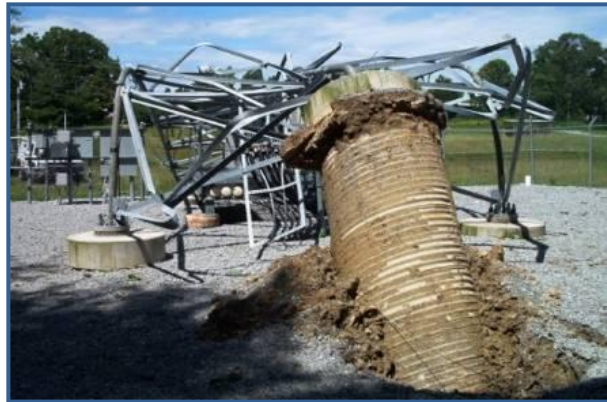
The photograph, *below*, is an *extreme*, yet not uncommon example of an *Installation Flaw*. Failure to remove the casing after the concrete was poured reduced the foundation skin friction and uplift capacity.

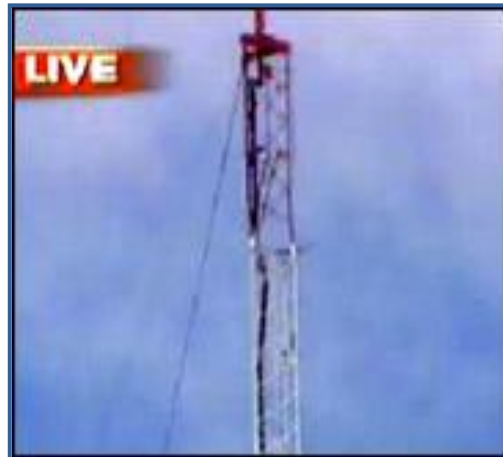
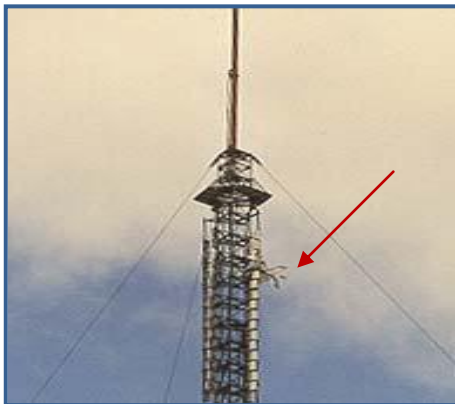
UPPER QUEBEC PROVINCE, CANADA – “On Sunday, April 22nd 2001, 38-year old Gilbert Paquette was killed when his single-engine Cessna 150 struck a 1,217-foot tall communications tower while flying in heavy fog during daylight hours over a remote region of upper Quebec Province.” Note the wreckage near the top right portion of the tower.

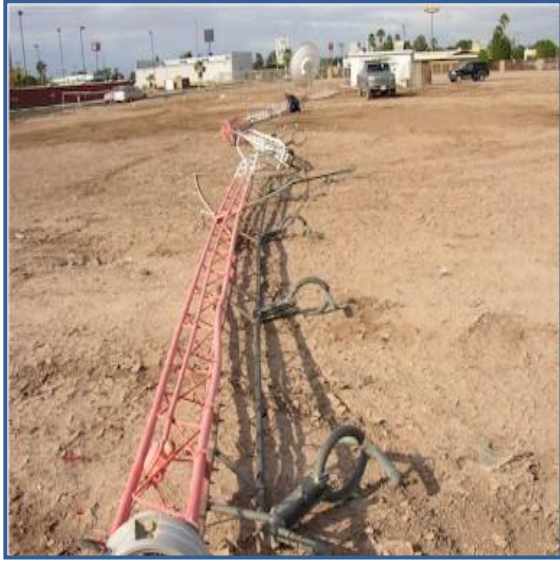
An earlier study conducted by *Stainless Tower, LLC* found anchor failure responsible for 5% of the broadcast tower failures. The **2010 CEI Study** provides concrete evidence that anchor failure is the reason **10% of all broadcast towers fail**. *We have seen a 100% increase in only 4 years!* What causes anchor failure? **Corrosion** of unprotected and buried steel members can cause anchor failure.

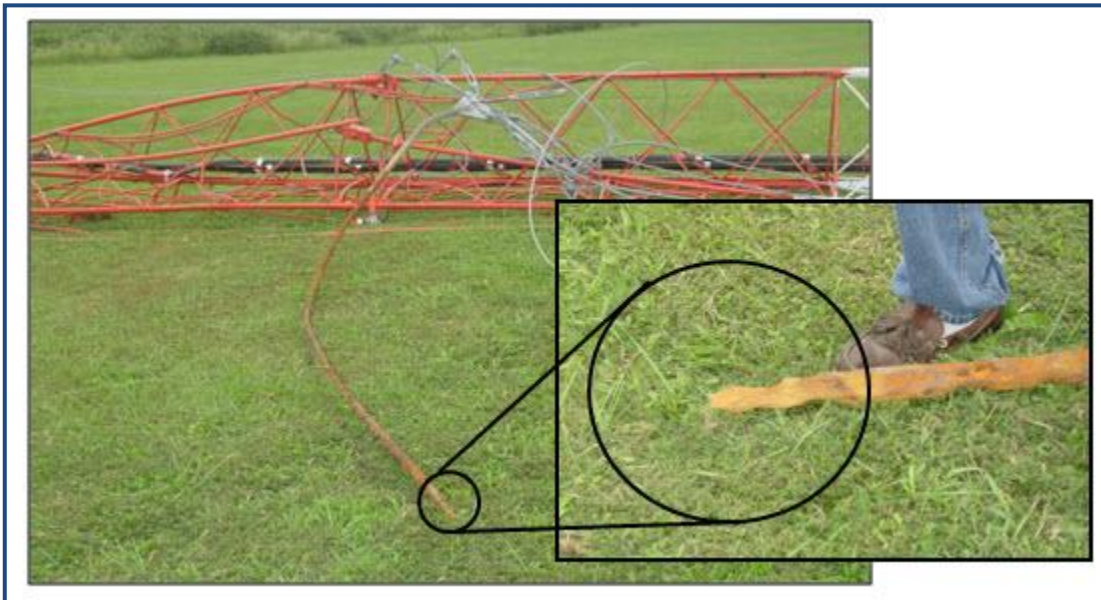
Corroded Anchor Rods, *shown below:*

Corrosion of an anchor shaft is the result of an *electrochemical process or galvanic action*, causing metal to deteriorate. *A galvanic cell requires five elements:*

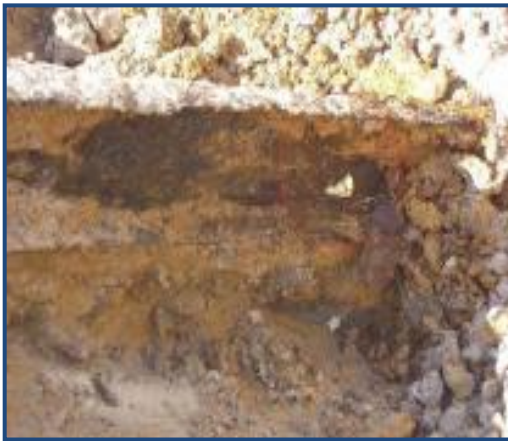
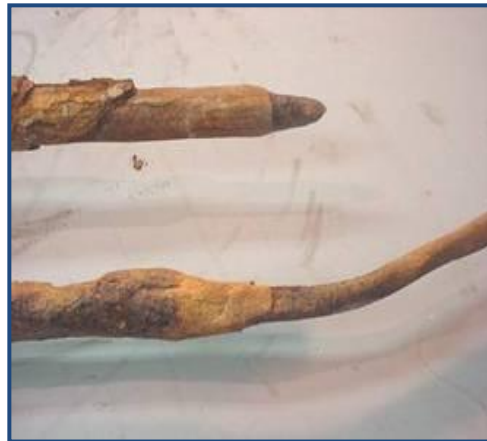
EXTERNAL CORROSION Caused by *Dissimilar Metals* in Guy Tower Anchor

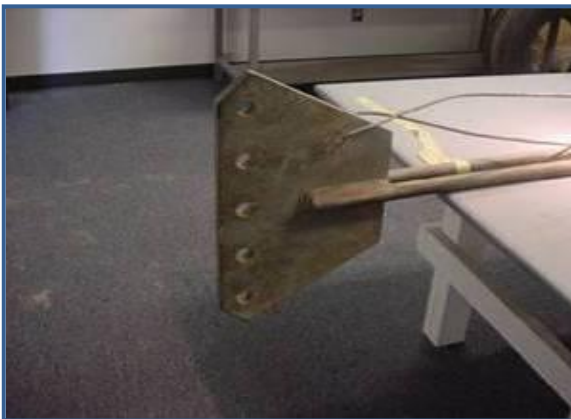
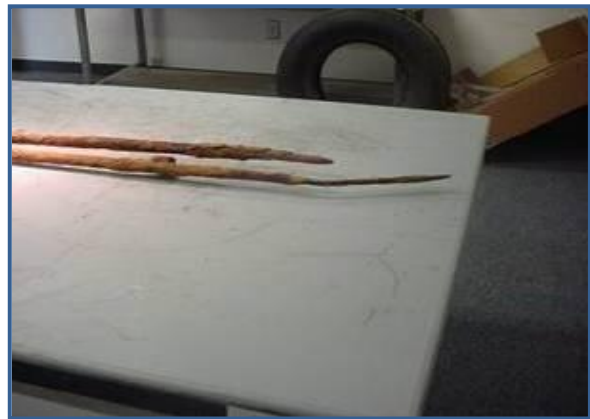
Limited excavation is not indicative of rod condition, *see photos above*
