NORTH AMERICAN TOWER FAILURE

CAUSES AND CURES

DAVID K. DAVIES

CONSOLIDATED ENGINEERING, INC

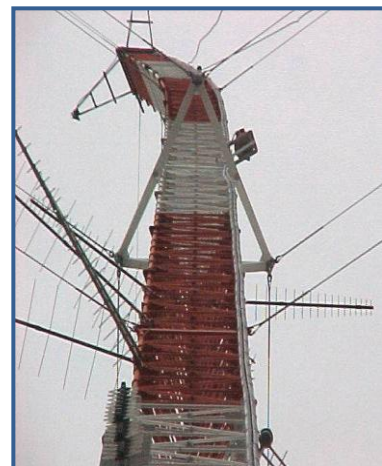
Guy wire slippage causes unplanned and often unequal forces to be placed on the structure. In many cases, a dynamic change in the loading condition of the tower connections results.

Guyed towers are typically designed so the majority of the vertical leg members are in compression, experiencing virtually no tension forces.

Consequently, the loss of a *single* guy wire during erection of a new tower or when reinforcing an existing tower, will put unexpected tension loads on one or more tower legs, often resulting in failure.

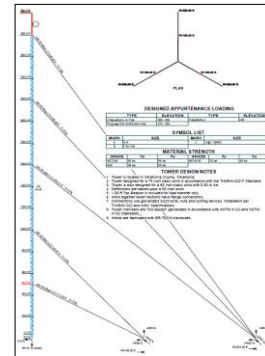
- 350 foot “Utility” guyed tower
- Typical FM tower
- Designed using the “C” code, **no ice**
- Analyzed using (1) “F” Code, with ice
- Analyzed using (2) “G” Code, with ice

When the tower was analyzed using the original design code, **EIA 222-C**, no structural deficiencies were noted, but ice accumulation was not considered, either.

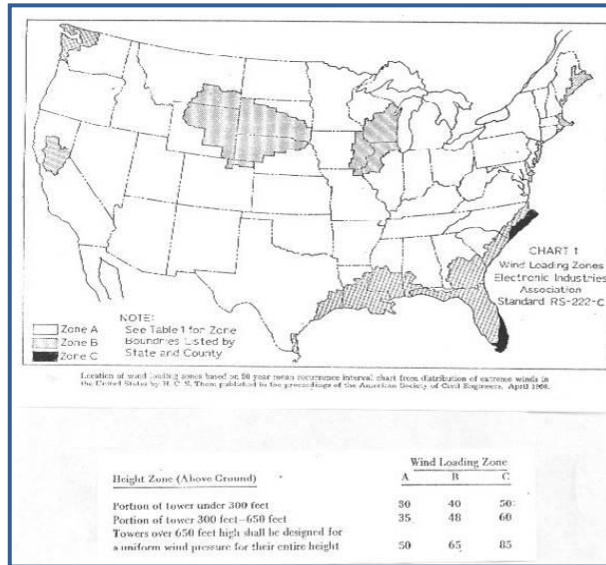
Compare the two maps, *shown left and below*. The map on the left was published in the **EIA RS-222 (A-C)**, the Standard from 1949 to 1985. The **D thru F Standard**, implemented in 1986, brought us the *Fastest-Mile Wind Speed*, see below.

The **EIA/RS-222-C** Standard converted a ‘basic’ wind speed to a wind pressure. The country was divided into three separate areas, each with differing wind pressure requirements. Zone A required a 30 psf design. Zone B required a 40 psf design and Zone C, a 50 psf design. Tower designers weren’t required to determine the appropriate wind speed, only the prescribed wind pressure, as dictated by the map, shown above.

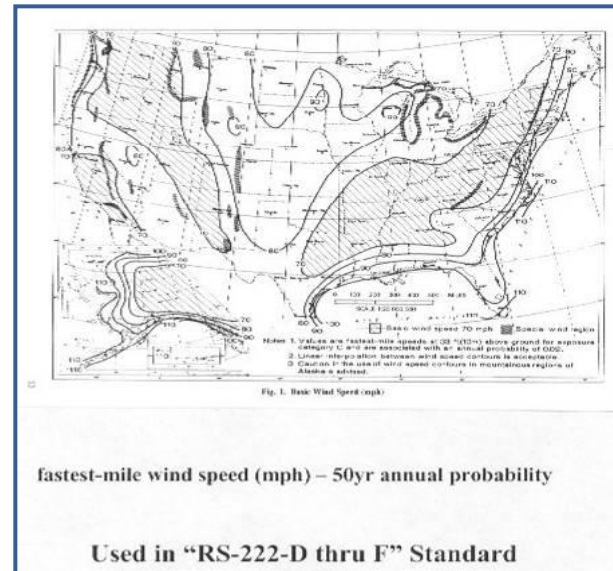
The **EIA/RS-222-D through F Revisions** eliminated the simplified three zones and their associated wind pressure by substituting a ‘wind map’ prescribing the appropriate wind speed according to location. Wind speed was referred to as *Fastest Mile Wind Speed*, or the average speed measured during the passage of one mile of wind. In other words, the average time between the peak and lull wind speeds fluctuated as a function of the wind’s velocity. For example, a 60 mph fastest mile wind speed would represent an average of the fluctuating wind velocities for 60 seconds. This is not the wind speed reported on the 6 o’clock news. Nor is it what county building officials expect to see displayed on submitted tower designs.

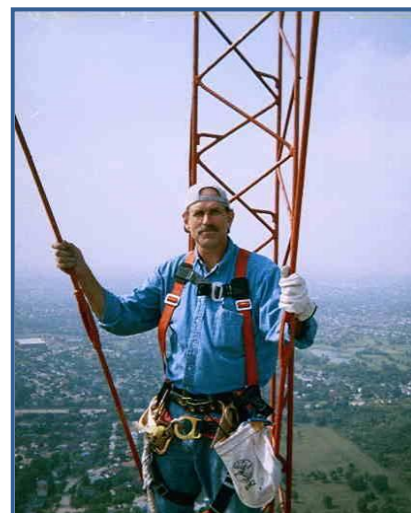
“In every wind induced tower failure I have investigated, the tower would not have passed the current design code” says Forensic Engineer, Ernie Jones, PE, of Consolidated Engineering, Inc.

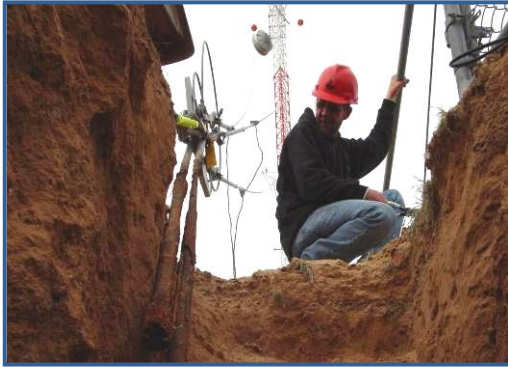
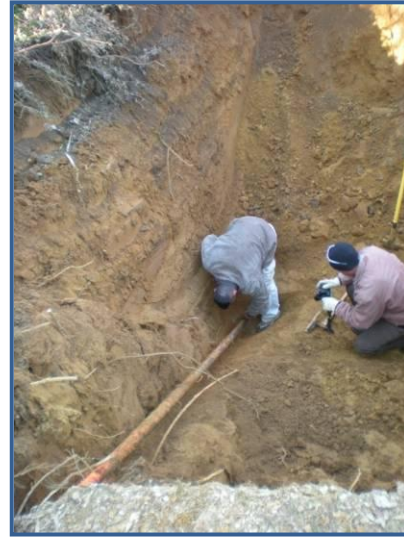
- 2. Total Excavation:** Involves removing the majority of the soil surrounding the anchor shaft and concrete anchor. While providing an unparalleled view of the anchor shaft, this invasive approach eliminates the majority of the anchor's uplift resistance. For safety and liability reasons, only experienced excavators are able to complete these inspections. This method can be cost-prohibitive, with the results are destructive and often tragic. The digging process could cause the sudden release of a compromised anchor shaft. Consequently, site limitations can render the anchor impossible to completely excavate.

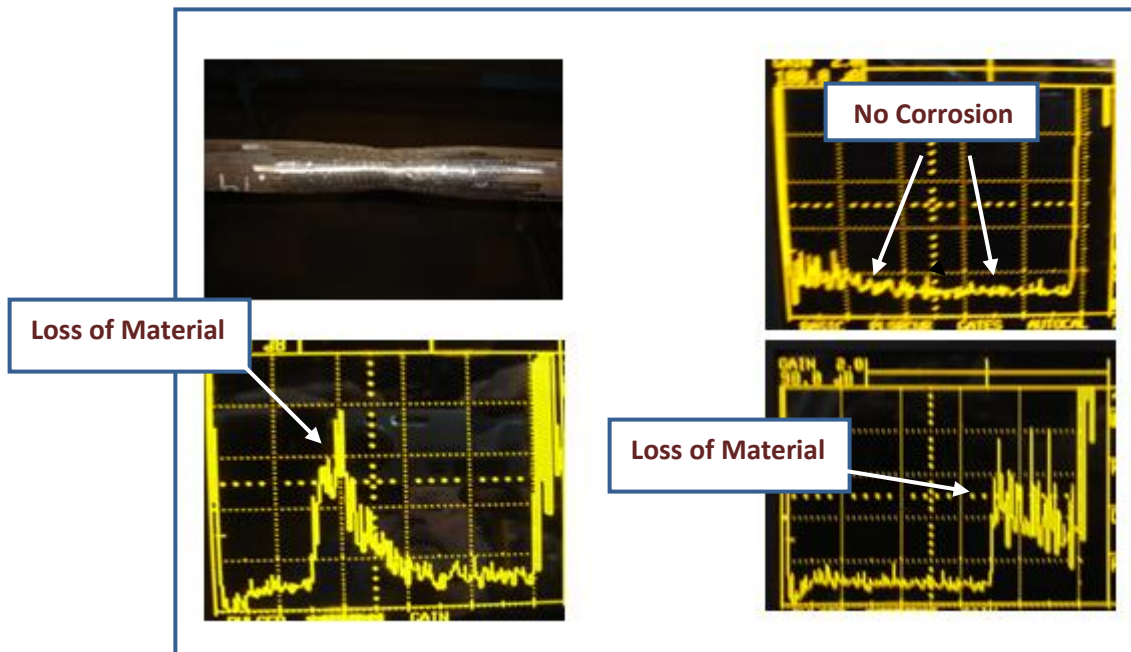
CEI Ultra™ Test Results

Ultrasound testing is a practical means for interrogating anchor shafts from the surface, avoiding the problems associated with excavation. When properly administered, this method will locate and estimate the extent of corrosion damage and loss of steel material. Ultrasound testing is cost-effective and eliminates unnecessary destruction and liability concerns.

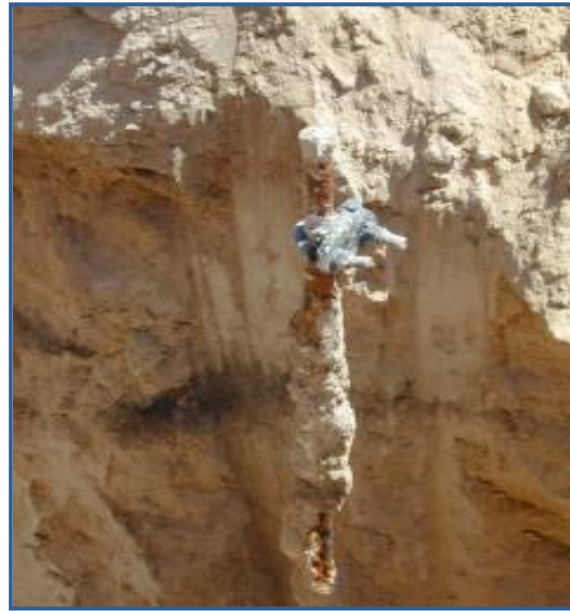
Unfortunately, sacrificial anodes may simultaneously *reduce* the effectiveness of the tower grounding system via the transference of insulating material directly to the grounding electrode. The photo, *right*, displays a grounding rod originally connected to a tower guying system which employed a sacrificial anode. Notice the isolative "coral-like" material coating the grounding rod. Increased resistance in the anchor grounding system increases the likelihood of damage to the anchor as a result of a lightning strike.

The AG Rod™ is a viable option for avoiding the problems associated with most sacrificial anodes through combining the sacrificial anode and the grounding system. The **AG Rod™** is a chemical grounding rod offering very low electrical resistance for fault currents. This accessory is comprised of a magnesium alloy which is significantly higher in the galvanic series than steel. The benefit is seen when the soil becomes sufficiently conductive. The **AG Rod™** sacrifices to the anchor shaft, preventing corrosion. Furthermore, electrical resistance of the **AG Rod™** decreases over time, as opposed an increase in electrical resistance using a standard copper base grounding rod equipped with a separate sacrificial anode
